**Telegraph And Telephone Lines &
Applegate Trail At Smith Hill Pass: 1940 - 1941**

Photographs 1 - 6

**For
Hugo Neighborhood Association & Historical Society &
Josephine County Historical Society**

December 27, 2011

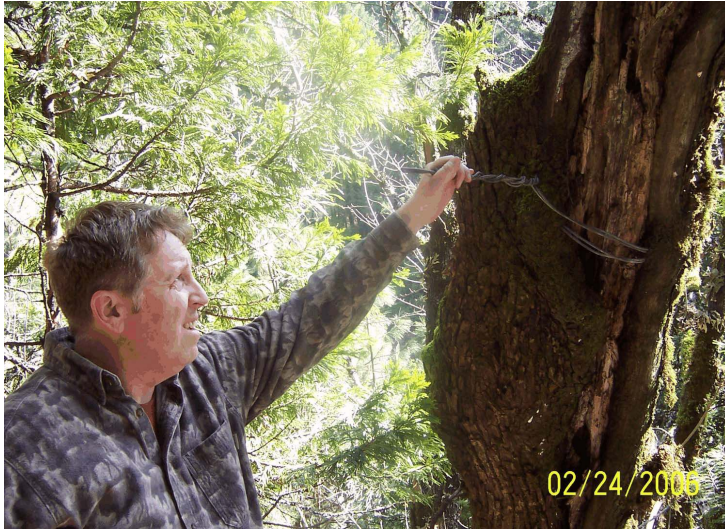
*Photo 1AA. Howard Banks Inspecting Galvanized Steel
Telegraph Wire At 310' Segement Of Applegate Trail
South Mt. Sexton Pass*

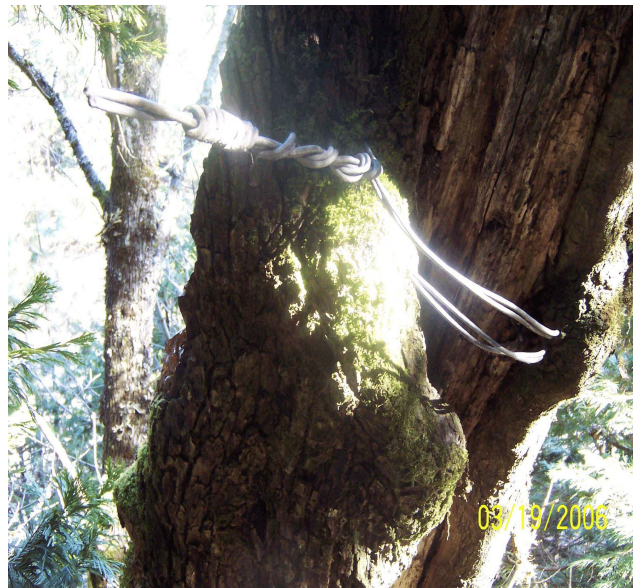
*Photo 1AB. Galvanized Steel Telegraph Wire
South Mt. Sexton Pass*

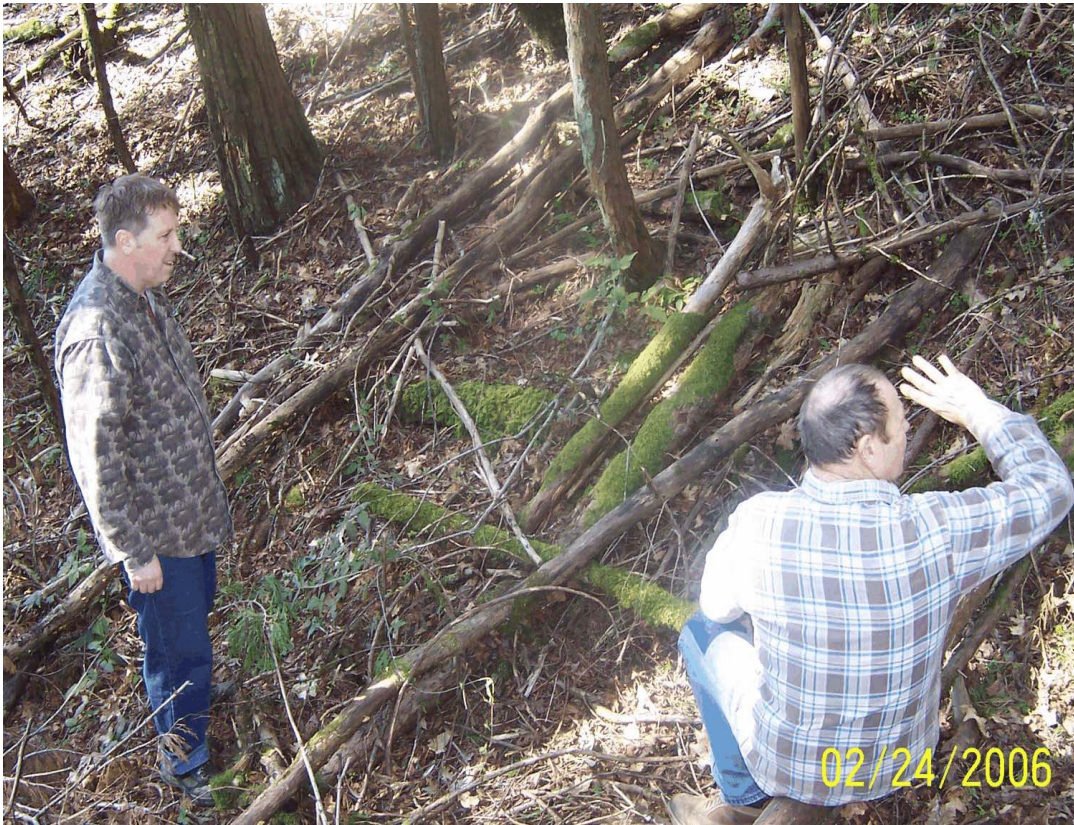
*Photo 1B. Howard Banks & Norbert Tieman Near
Postal Telegraph Pole At South Mt. Sexton Pass: 2006*

**Photo 1B. Howard Banks & Norbert Tieman Near Postal Telegraph Pole
At South Mt. Sexton Pass: 2006**

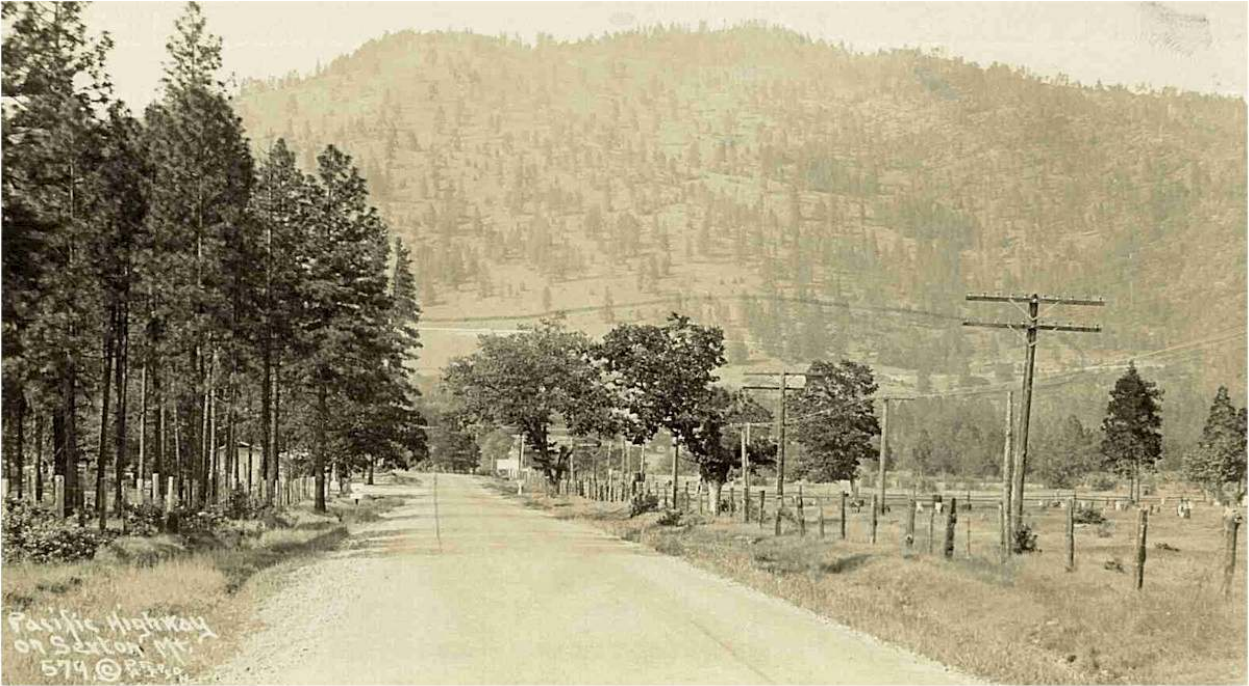
Photo 2. Pacific Highway Communication Lines With Sexton Mt. In Background: ca., 1920s

The picture is the old Pacific Highway in northern Josephine County in the mid-1920s. Mt. Sexton is in the background. The road was in the same location in 2011 as “Oxyoke Road”. Photo 2 is a classic of the evolution of the telegraph lines to telephone lines.

The poles with 10-pin double cross-arms are the AT&T's long distance phone line; the poles with a single arm are the Postal Telegraph.

Postal Telegraph (PT) lines were built through Josephine County around 1886 - 1887. The PT company operated the line until they had a six-pin single cross arm.

American Telephone and Telegraph (AT&T) built long telephone distance lines through Josephine County in the 1920s. Service from these overhead lines continued until the mid to late 1950's when the lines were replaced with buried cable.

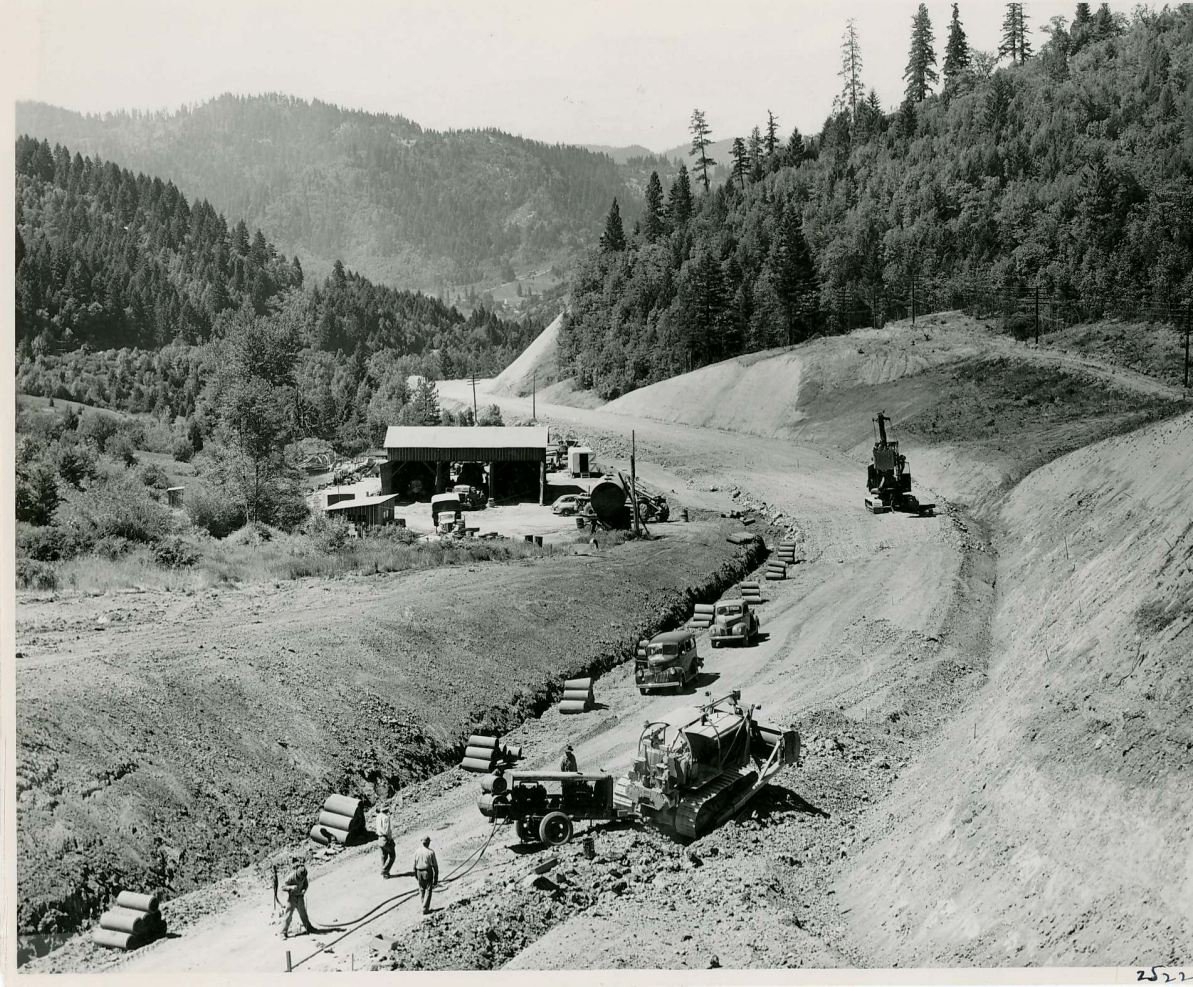
Photo 3A. Looking North From Mt. Sexton Summit At Communication Lines: 1941
Courtesy of the Oregon Department of Transportation

This photograph is of the 1941 Pacific Highway Cut North of Mt. Sexton. Rat Creek is the drainage on the upper left of the picture and at the upper middle left is the bottom land of Sunny Valley.

The evolved Applegate Trail (ca., 1910 - 1920) is in the upper right of the photo with the evolved AT& T Line and the Postal Telegraph Line. This location is today part of the 1,060' Applegate Trail I North Sexton Pass I-5 East location (see Photo 3B for a blow-up of the AT& T and PT lines and more details on the communication lines).

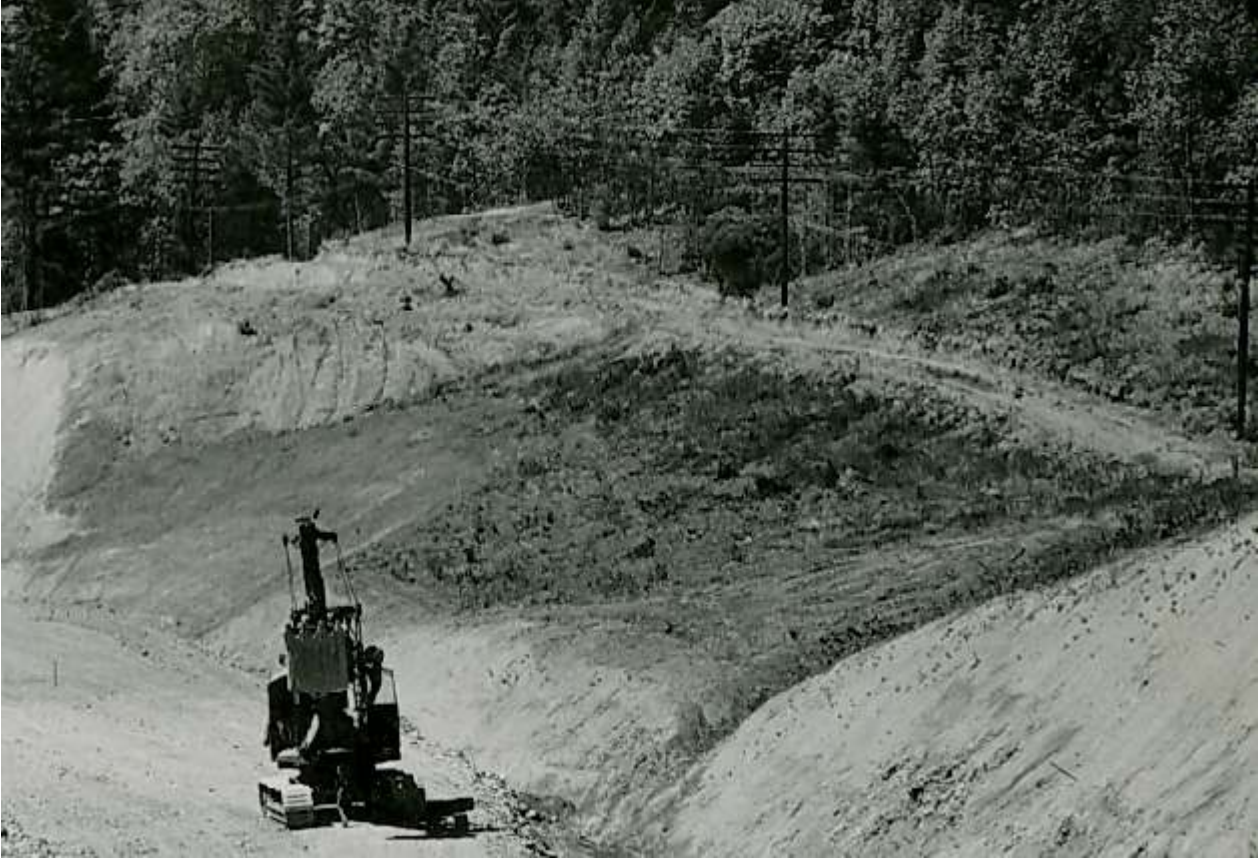
Photo 3B. AT&T & PT Communications Lines At North Sexton Pass: 1941

Photo 3B. Photo 3B Is for a blow-up of the AT& T and PT Lines In Photo 3A

The evolved Applegate Trail (ca., 1920s) is in the upper right of the photo with the evolved AT& T Line and the Postal Telegraph Line. This location is today part of the 1,060' Applegate Trail I North Sexton Pass I-5 East location.

AT& T Line has evolved from a 10-pin double cross-arms to a 10-pin quadruple cross-arms. The PT Line poles still have a single cross-arm. The PT Line poles are hard to see in photo. It is the lowest single line beneath the AT&T's quadruple cross-arm lines.

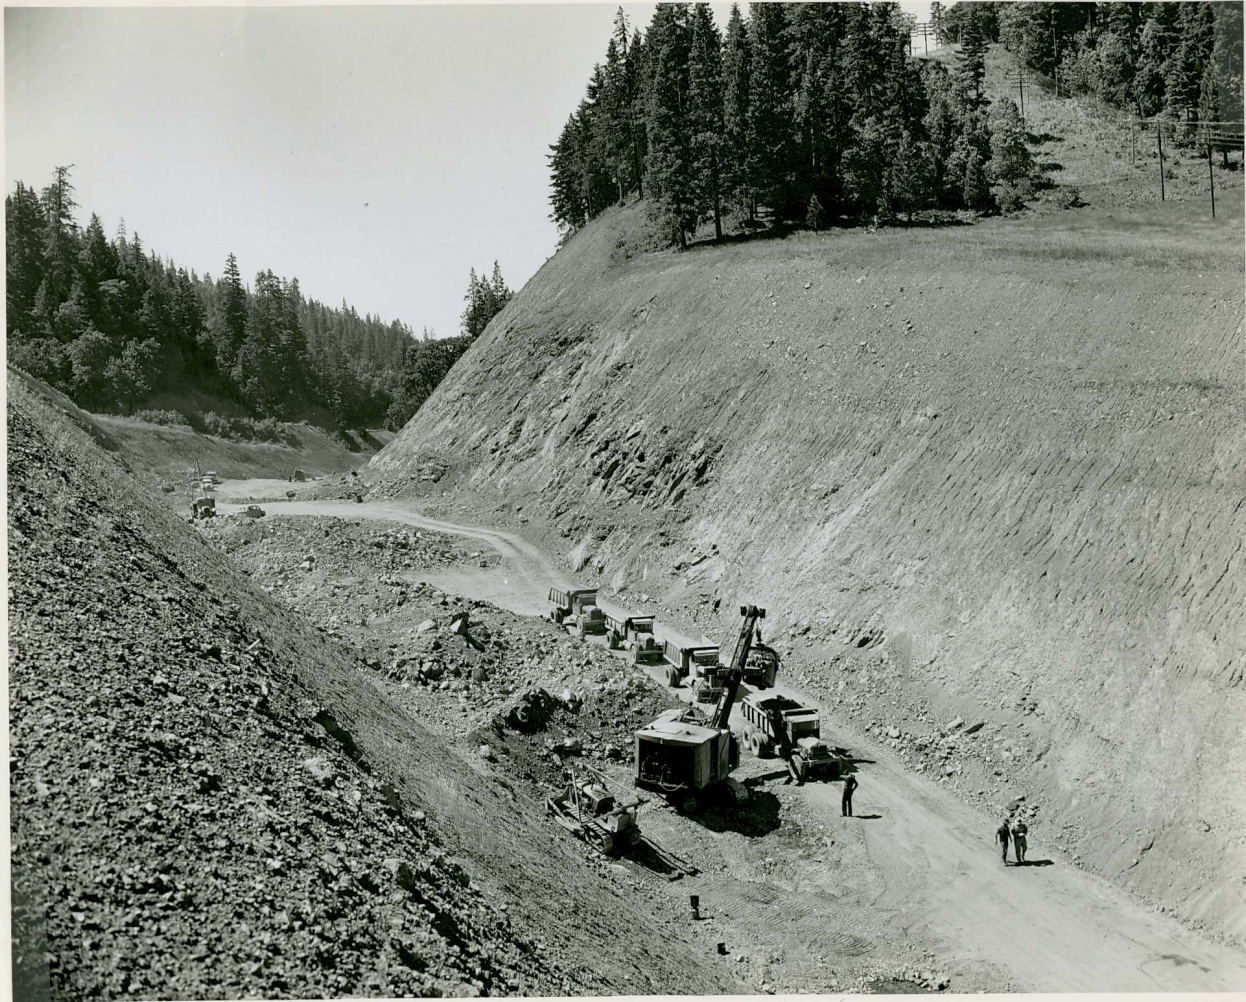
Photo 4A. South View Of AT&T 60' ROW Communication Lines In West Field At North Sexton Pass: 1940
Courtesy of the Oregon Department of Transportation

This photograph is a south view of AT&T 60' Right-of-way (ROW) in west field at North Sexton Pass: 1941 (Maps 2, 3, 4, 5, and 6 for different locations of the ROW on both sides of Sexton Mt. Pass). The view in this picture of the AT&T and PT lines can be found on Map 2.

This location was never part of the Applegate Trail. It was an evolved communication line ROW independent of the road system.

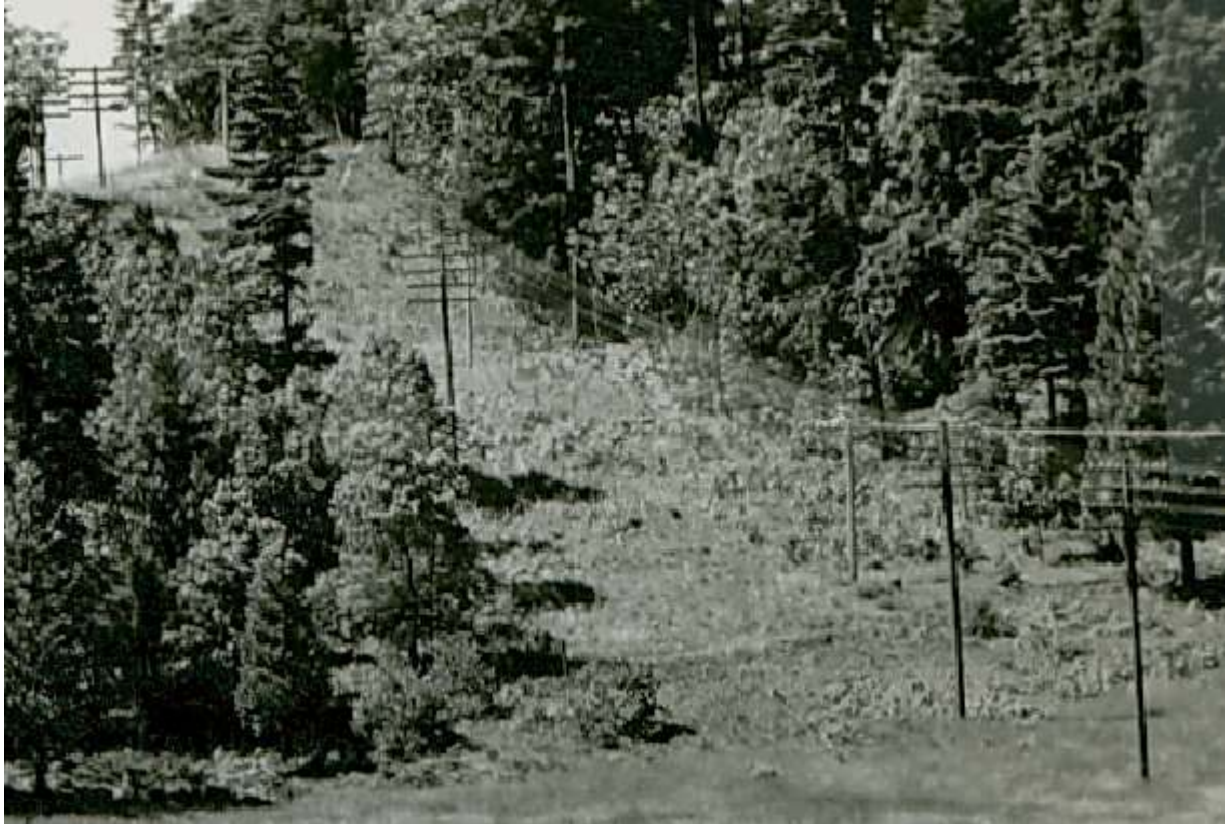
*Photo 4B. AT&T & PT Communications Lines Within AT&T 60' ROW
In West Field At North Sexton Pass: 1940*

Photo 4B Is for a blow-up of the AT& T and PT Lines In Photo 4A

The AT& T Line and PT Line with their individual poles and wire are easy to view in this picture.

When compared to Photo 2, the AT& T Line has evolved from a 10-pin double cross-arms to a 10-pin quadruple cross-arms. The PT Line poles still have a single cross-arm.

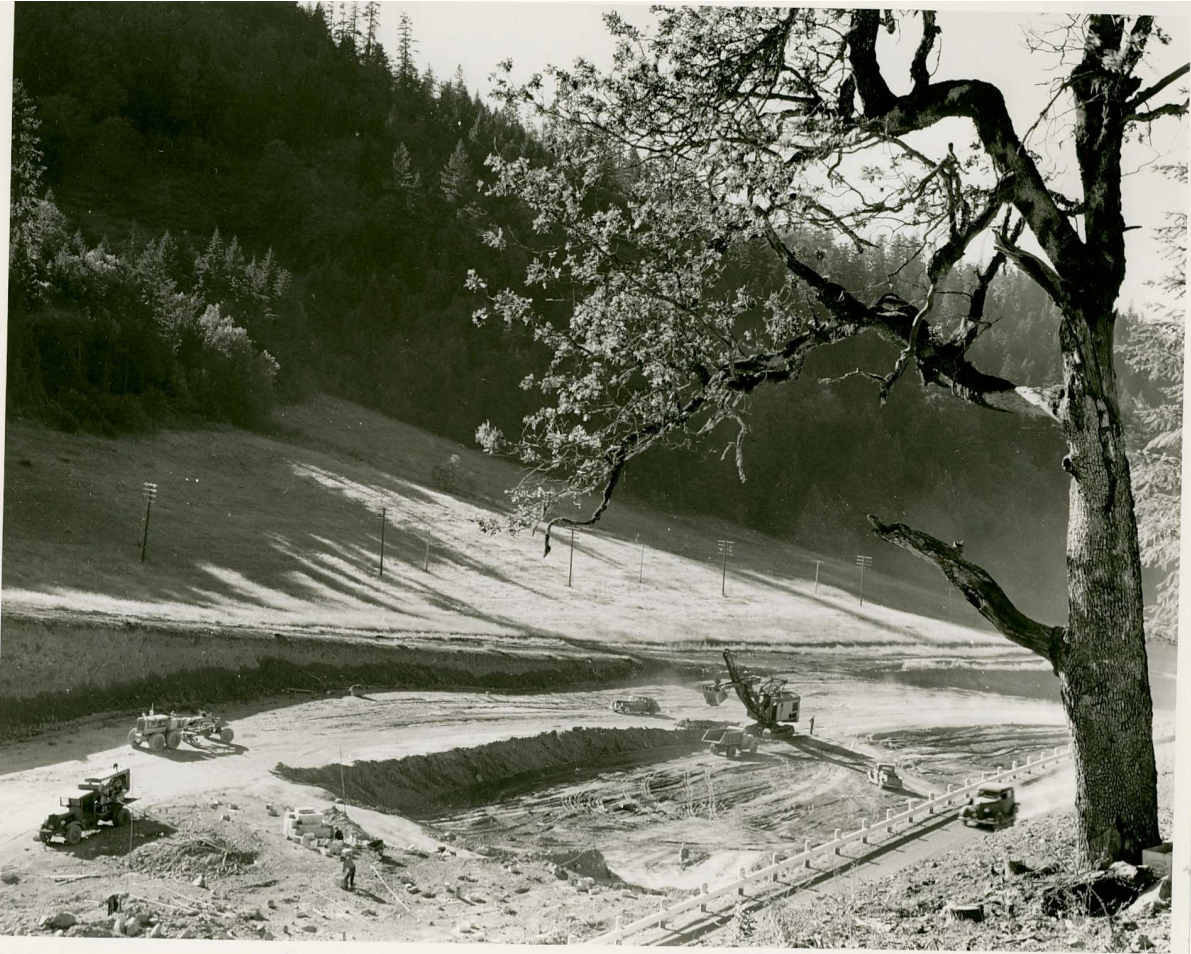
**Photo 5A. West View Of AT&T 60' ROW Communication Lines
In West Field At North Sexton Pass: 1940**

This photograph is a western view of AT&T 60' Right-of-way (ROW) in west field at North Sexton Pass: 1940 (Maps 2, 3, 4, 5, and 6 for different locations of the ROW on both sides of Sexton Mt. Pass). The view in this picture of the AT&T and PT lines can be found on **Map 2**.

This communications line location was never part of the Applegate Trail. It was an evolved communication line ROW independent of the road system.

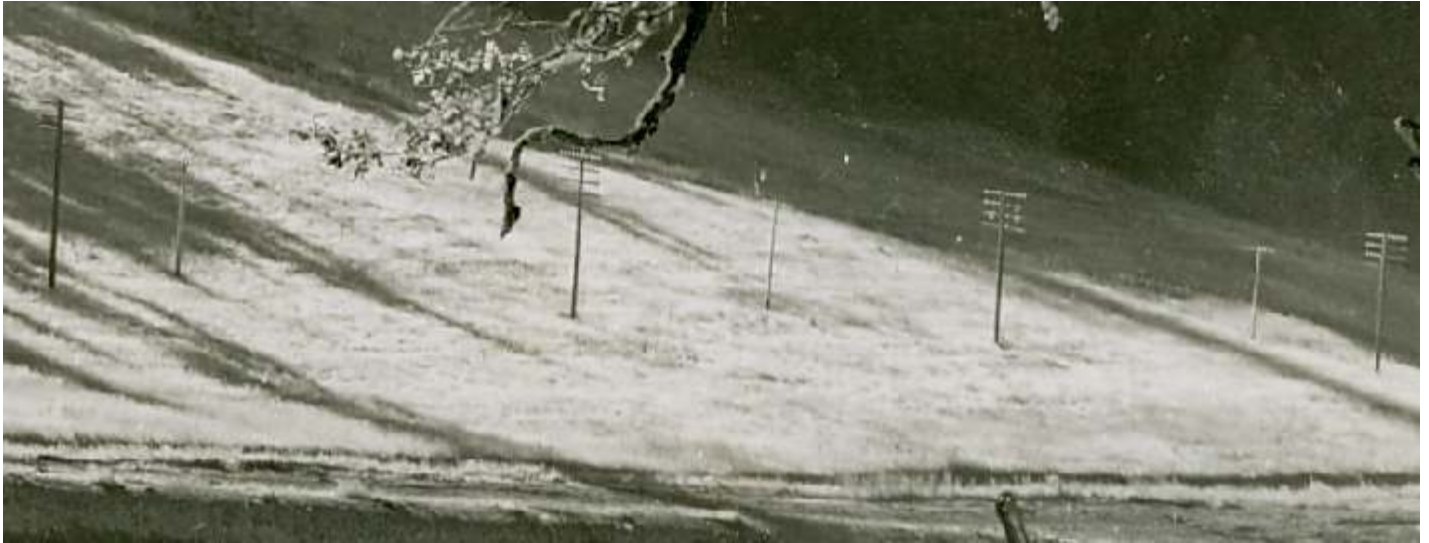
Photo 5B. AT&T & PT Communications Lines In West Field At North Sexton Pass: 1940

Photo 5B Is for a blow-up of the AT& T and PT Lines In Photo 5A

The AT& T Line and PT Line with their individual poles and wire are easy to view in this picture.

When compared to Photo 2, the AT& T Line has evolved from a 10-pin double cross-arms to a 10-pin quadruple cross-arms. The PT Line poles still have a single cross-arm.

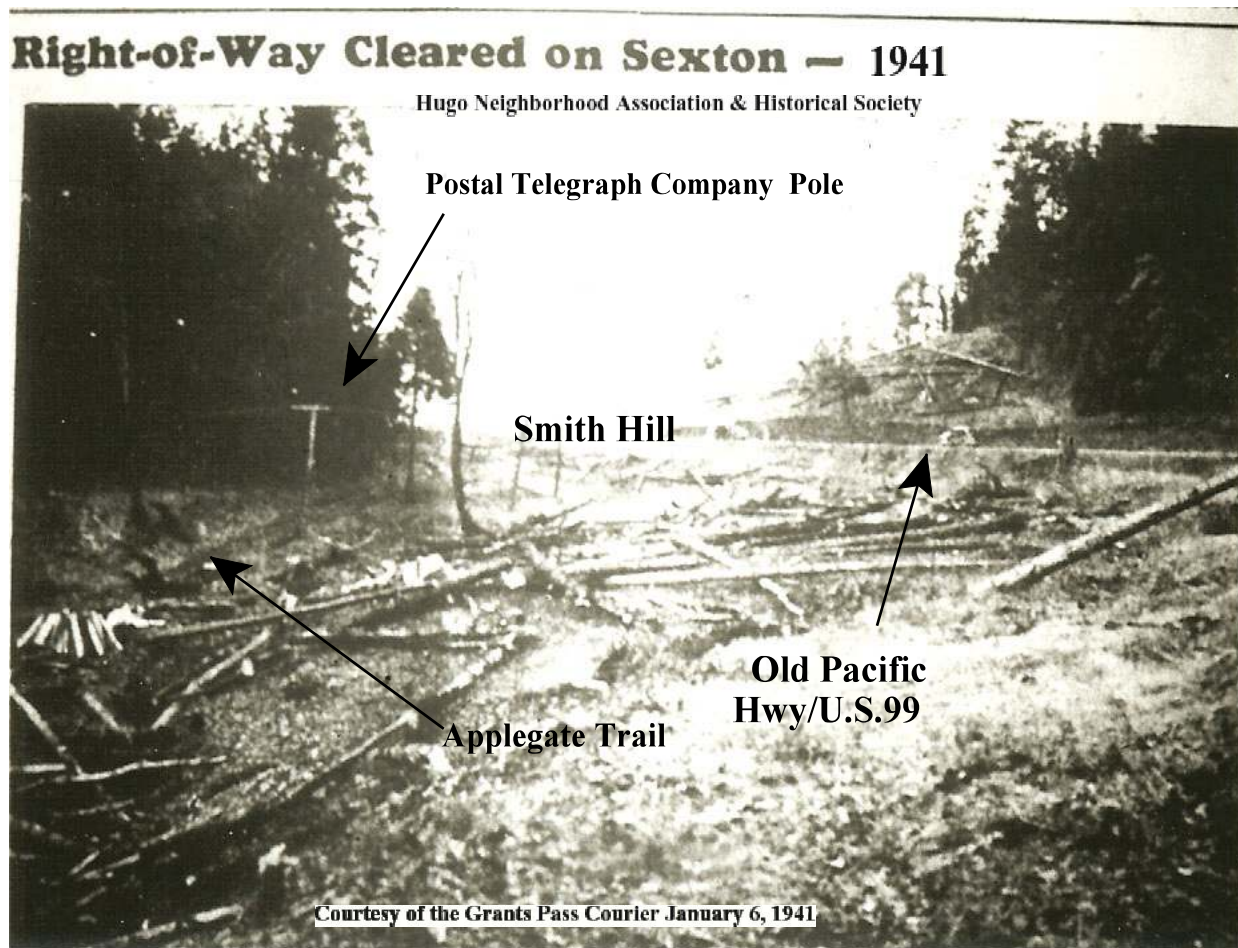
Photo 6. Right-Of-Way Cleared On Mt. Sexton Pass: 1941
Courtesy of Grants Pass Daily Courier

1941 Right-of-way Cleared on Sexton The photo is courtesy of the *Grants Pass Courier* with the following caption.

“The residence [John S. W. Smith homesteaded in 1877; he was issued a homestead patent for 160 acres in Hugo, Oregon September 16, 1896 (Patent No. 3749)] overlooking the Pacific highway summit [Smith Hill] on the shoulder of Mt. Sexton has been razed, and trees are being felled for 1.92 miles of new construction soon to take place there. Here is a view toward the summit from the Grants Pass side showing the steep, old dirt road on the left [Applegate Trail], the curving present highway on the right [Old Pacific Highway/U.S. 99], and the felled trees on the right-of-way of the new work. The highway summit will be lowered several feet by a deep cut. (Courier Photo and Engraving.)” Clarification Added.
